**Flood Control Project Maintenance
Levee Inspections**
LMA District Cover Sheet
Spring 2018 Levee Inspection Results

Sutter Maintenance Yard Maintenance Area 0007

Levee Inspection Report By Mile - Spring 2018

Waterway	Bank	Unit Miles	Inspection Start/End	Inspector
Unit No. 01 Feather River	Right	11.90	03/20/2018 03/20/2018	Sterling York

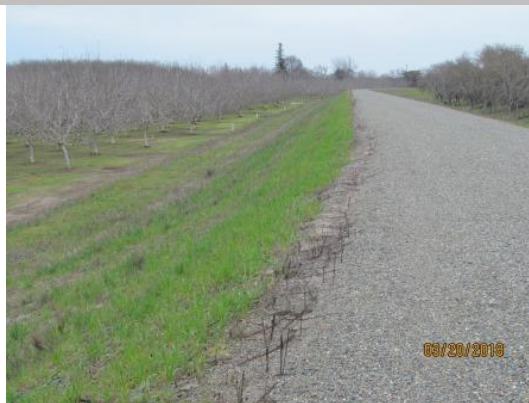
Photo 1 of 3 : SP_2018_MA0007_200_12_20180402_00031.jpg

LM Start	0.00	Rating **	A	Issue No.	12
LM End	11.88	Issue Type +	Ma	Location *	LS
Category	Earthen Levee			GPS Latitude/Longitude	
				Start	End
Item	Vegetation			39.310097 °	39.439682 °
				-121.637894 °	-121.641718 °
DWR ID	DWR_MA0007_01_s_2018_12				
Comment Code					
V1 : Control annual grass and weeds on the levee slopes and easements.					
Inspector Comment					
The annual vegetation is well maintained, Spring 2018.

View looking upstream landside near Levee Mile 0.0 of the well maintained annual vegetation, Spring 2018.

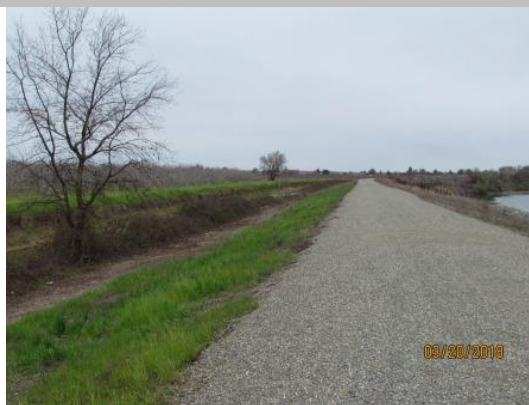
Photo 2 of 3 : SP_2018_MA0007_200_12_20180402_00030.jpg

View looking upstream landside near Levee Mile 7.5 of the well maintained annual vegetation, Spring 2018.

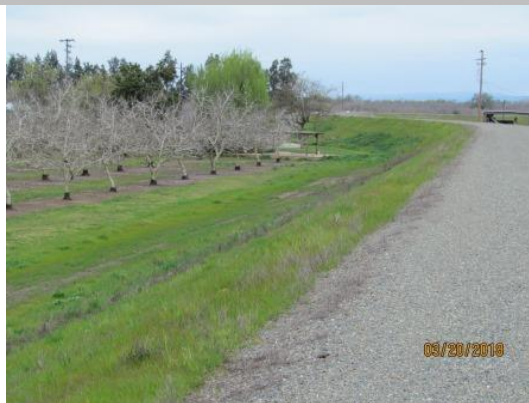
Photo 3 of 3 : SP_2018_MA0007_200_12_20180402_00032.jpg

View looking upstream landside near Levee Mile 11.36 of the well maintained annual vegetation, Spring 2018.

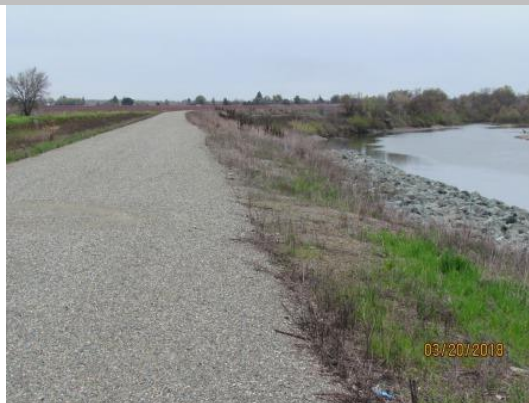
Photo 1 of 3 : SP_2018_MA0007_200_13_20180402_00033.jpg

LM Start	0.00	Rating **	A	Issue No.	13
LM End	11.88	Issue Type +	Ma	Location *	WS
Category	Earthen Levee			GPS Latitude/Longitude	
				Start	End
Item	Vegetation			39.310097 °	39.439682 °
				-121.637894 °	-121.641718 °
DWR ID	DWR_MA0007_01_s_2018_13				
Comment Code					
V1 : Control annual grass and weeds on the levee slopes and easements.					
Inspector Comment					
The annual vegetation is well maintained, Spring 2018.

View looking upstream landside near Levee Mile 0.0 of the well maintained annual vegetation, Spring 2018.

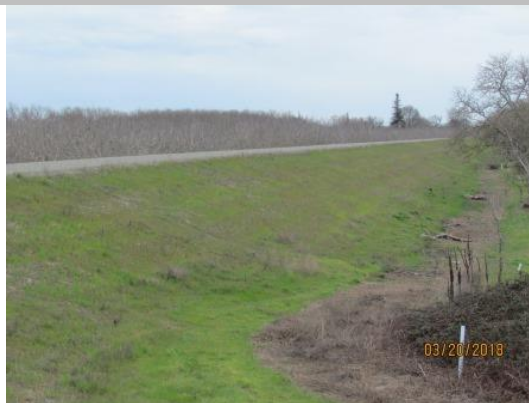
Photo 2 of 3 : SP_2018_MA0007_200_13_20180402_00034.jpg

View looking upstream landside near Levee Mile 7.5 of the well maintained annual vegetation, Spring 2018.

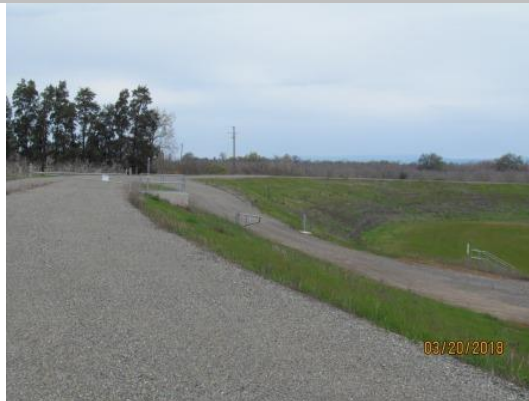
Photo 3 of 3 : SP_2018_MA0007_200_13_20180402_00035.jpg

View looking upstream landside near Levee Mile 11.47 of the well maintained annual vegetation, Spring 2018.

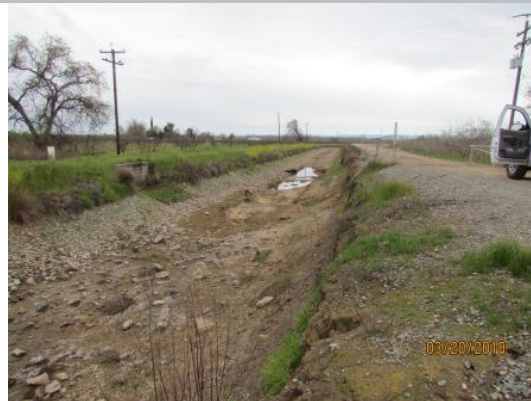
Photo 1 of 1 : SP_2018_MA0007_200_66_20180402_00036.jpg

LM Start	0.01	Rating **	U	Issue No.	66
LM End	1.73	Issue Type +	En	Location *	LS
Category	Earthen Levee			GPS Latitude/Longitude	
				Start	End
Item	Encroachments			39.311103 °	39.334487 °
				-121.637605 °	-121.634109 °
DWR ID	DWR_MA0007_01_s_2016_66				
Comment Code					
DT : Ditch					
Inspector Comment					
There are substantial bank issues on the landside levee slope along the entire length of the irrigation ditch. Spring 2018.

View looking upstream landside of erosion, this is continuing to get worse. Fall inspection the ditch is full with water but the erosion issue still exist, Spring 2018.

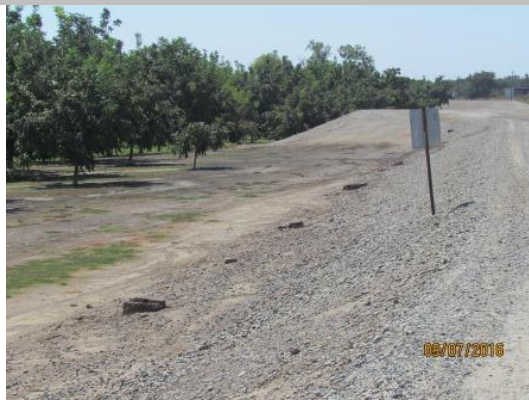
Photo 1 of 1 : SP_2018_MA0007_200_69_20180302_00013.jpg

LM Start	0.31	Rating **	N	Issue No.	69
LM End	0.37	Issue Type +	Ma	Location *	WS
Category	Earthen Levee			GPS Latitude/Longitude	
				Start	End
Item	Trim / Thin Trees			39.314991 °	39.315693 °
				-121.635038 °	-121.634459 °
DWR ID	DWR_MA0007_01_s_2016_69				
Comment Code					
T5 : Tree stumps.					
Inspector Comment					
Several tree stumps at levee toe still exist Fall 2017.

View looking downstream of several tree stumps at the levee toe on the waterside, still exist Fall 2017.

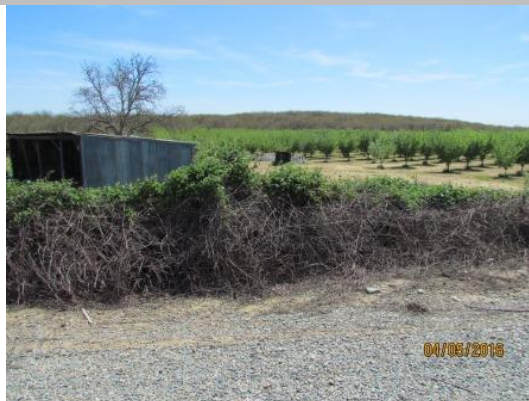
Photo 1 of 1 : SP_2018_MA0007_200_67_20180302_00010.jpg

LM Start	0.92	Rating **	A/W	Issue No.	67
LM End	0.92	Issue Type +	Ma	Location *	LS
Category	Earthen Levee			GPS Latitude/Longitude	
				Start	End
Item	Vegetation			39.323118 °	39.323118 °
				-121.632205 °	-121.632205 °
DWR ID	DWR_MA0007_01_s _ 2016_67				
Comment Code					
V2 : Remove the wild growth other than native grasses from the levee slopes.					
Inspector Comment					
The black berry bushes are continued to be sprayed and maintained at the levee toe, Fall 2017.

View of landside toe vegetation looking downstream.

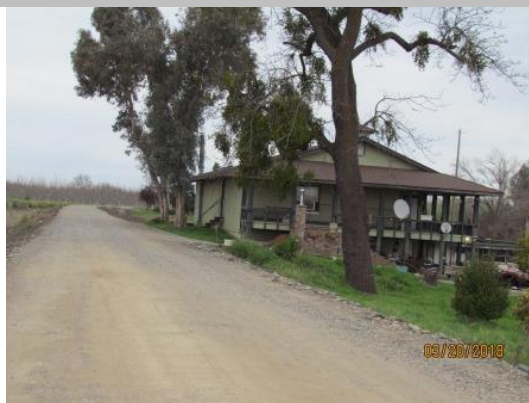
Photo 1 of 1 : SP_2018_MA0007_200_33_20180402_00038.jpg

LM Start	1.21	Rating **	U	Issue No.	33
LM End	1.21	Issue Type +	En	Location *	WS
Category	Earthen Levee			GPS Latitude/Longitude	
				Start	End
Item	Encroachments			39.327187 °	39.327187 °
				-121.632395 °	-121.632395 °
DWR ID	DWR_MA0007_01_s _ 2012_33				
Comment Code					
BU : Building					
Inspector Comment					
No permit found for this residence, Spring 2018.

Levee mile 1.21. This is a photo of the building on the waterside slope, Spring 2018.

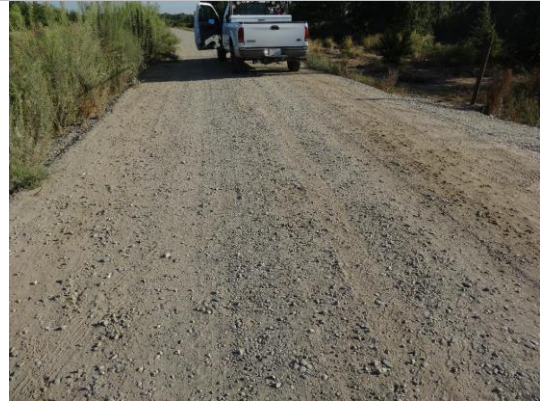
Photo 2 of 3 : UCIP_SP_2018_52408_77327.jpg

Comment Code						
Inspector Comment						
FS_ID:52408 DS_ID:16928 EP_NO: N/A Repair Type: Non-Urgent Crossing Status: Found UCIP Comments: 08/09/2017 Crossing is still present, no modifications were made to this crossing. Crossing still appears to be abandoned and not in use, recommend contacting owner to determine status of crossing. This pipe was not part of the Feather River West Levee Improvements, Project D. Pipe is located outside the project limits. Project Improvements began at Station (Sta) 1765+00 (MA0007 about LM 1.73) to Sta 2303+50 (ST0005 about LM 1.23), refer to record drawings for the Feather River West Levee Improvement Plans Station 1765+00 to 2368+26, Project D details. (DWR UCIP - O. Magana)08/02/2017 Unknown if crossing was modified, not shown in record drawings. (DWR UCIP - O. Magana) 5/16/2016 Feather River West Levee Improvement Project--Levee currently under construction.6/10/2015 Same as last inspection.12/29/2014 Same as last inspection.5/19/2014 Same as last inspection.11/6/2013 Same as last inspection.5/13/2013 SBFCA project recommends replacing in accordance with title 23.5/10/2013 Same as last inspection. LS scour behind structure needs to be repaired.10/31/2012 crossing appears abandoned, slide gate is missing on landward side; wood frame remains on LS; scour hole present on LS, 3 feet by 3 feet, near wood frame. FIELD_STRUCT_DESC: *ABANDONED* 12-inch corrugated metal drainage pipe through the levee, 8.2 feet below the crown. Slide gate on the landside (LS) is no longer present. Concrete "U" headwall at the waterside (WS) toe. Irrigation ditch located on the LS. [Additional Reference(s): DWR Levee Log, 2005] FS Date: 8/9/2017

Overview of levee at crossing looking upstream.

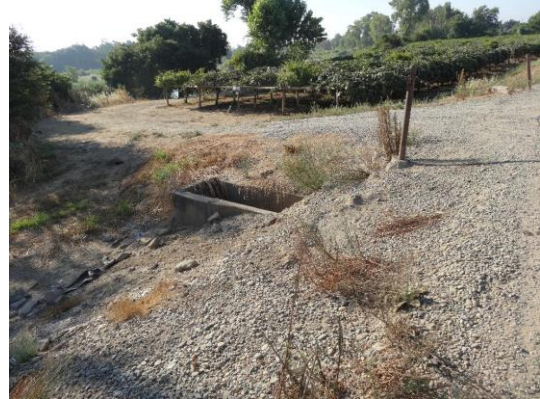
Photo 3 of 3 : UCIP_SP_2018_52408_77325.jpg

Comment Code						
Inspector Comment						
FS_ID:52408 DS_ID:16928 EP_NO: N/A Repair Type: Non-Urgent Crossing Status: Found UCIP Comments: 08/09/2017 Crossing is still present, no modifications were made to this crossing. Crossing still appears to be abandoned and not in use, recommend contacting owner to determine status of crossing. This pipe was not part of the Feather River West Levee Improvements, Project D. Pipe is located outside the project limits. Project Improvements began at Station (Sta) 1765+00 (MA0007 about LM 1.73) to Sta 2303+50 (ST0005 about LM 1.23), refer to record drawings for the Feather River West Levee Improvement Plans Station 1765+00 to 2368+26, Project D details. (DWR UCIP - O. Magana)08/02/2017 Unknown if crossing was modified, not shown in record drawings. (DWR UCIP - O. Magana) 5/16/2016 Feather River West Levee Improvement Project--Levee currently under construction.6/10/2015 Same as last inspection.12/29/2014 Same as last inspection.5/19/2014 Same as last inspection.11/6/2013 Same as last inspection.5/13/2013 SBFCA project recommends replacing in accordance with title 23.5/10/2013 Same as last inspection. LS scour behind structure needs to be repaired.10/31/2012 crossing appears abandoned, slide gate is missing on landward side; wood frame remains on LS; scour hole present on LS, 3 feet by 3 feet, near wood frame. FIELD_STRUCT_DESC: *ABANDONED* 12-inch corrugated metal drainage pipe through the levee, 8.2 feet below the crown. Slide gate on the landside (LS) is no longer present. Concrete "U" headwall at the waterside (WS) toe. Irrigation ditch located on the LS. [Additional Reference(s): DWR Levee Log, 2005] FS Date: 8/9/2017

WS view: concrete box located on WS toe.

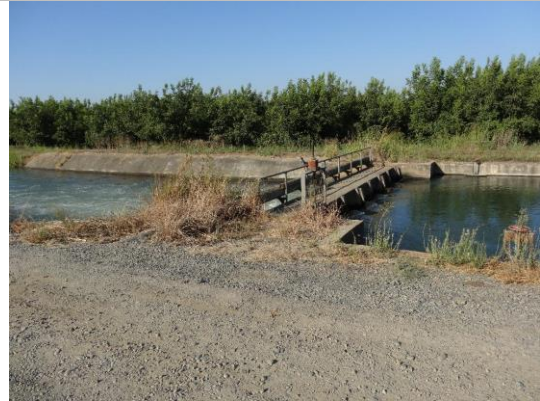
Photo 1 of 3 : UCIP_SP_2018_52386_77330.jpg

Comment Code					
Inspector Comment					
FS_ID:52386 DS_ID:20816 EP_NO: N/A Repair Type: Non-Urgent Crossing Status: Found UCIP Comments: 08/09/2017 It appears that this pipe is used to water the orchard located on the WS. Dense vegetation present along the WS slope, recommend clearing vegetation to allow for proper inspection of levee slope. No permit has been identified since 2012. (DWR UCIP - O. Magana)08/02/2017 After reviewing record drawings it appears this crossing has remained. This pipe was not part of the Feather River West Levee Improvements, Project D. Pipe is located outside the project limits. Project Improvements began at Station (Sta) 1765+00 (MA0007 about LM 1.73) to Sta 2303+50 (ST0005 about LM 1.23), refer to record drawings for the Feather River West Levee Improvement Plans Station 1765+00 to 2368+26, Project D details. (DWR UCIP - O. Magana) 5/16/2016 Feather River West Levee Improvement Project--Levee currently under construction.6/10/2015 Crossing has been modified since last inspection. 3' black plastic pipe is now running through the metal pipe and the difference was capped and welded. 12/29/2014 Same as last inspection.5/19/2014 Same as last inspection.11/6/2013 Same as last inspection.5/13/2013 SBFCA project recommends removal. Permit number and owner in detailed report book.5/7/2013 Same as last inspection. Recommend finding owner.10/30/2012 Crossing was installed about 1 foot deep--need permit authorizing work FIELD_STRUCT_DESC: 12-inch steel irrigation pipe through the levee, 1 foot below the crown. Crossing on the landside (LS) is attached to a weir above ground. Siphon breaker located on the waterside (WS). No opening on the WS. No permit has been identified since crossing was field discovered in 2012. (Existing 12-inch steel irrigation pipe crossing remained during the Feather River West Levee Improvements, Project D). [Additional Reference(s): Sutter Butte Flood Control Agency (SBFCA) Feather River West Levee Project, Volume 4 of 6 (Project D) Feather River West Levee Improvement Plans Sta 1765+00 to 2368+26, 2016, Volume 4-SBFCA_Record_Drawings_Project D_2017.05.16.pdf, Drawing No. C-101]. FS Date: 8/9/2017

LS view: pipe visible along LS canal.

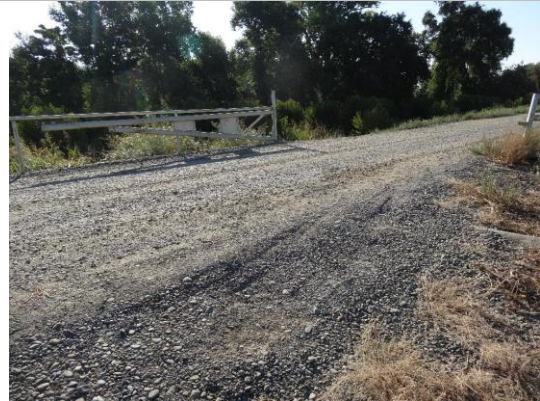
Photo 2 of 3 : UCIP_SP_2018_52386_77331.jpg

FS_ID:52386
DS_ID:20816
EP_NO: N/A
Repair Type: Non-Urgent
Crossing Status: Found
UCIP Comments: 08/09/2017 It appears that this pipe is used to water the orchard located on the WS. Dense vegetation present along the WS slope, recommend clearing vegetation to allow for proper inspection of levee slope. No permit has been identified since 2012. (DWR UCIP - O. Magana)08/02/2017 After reviewing record drawings it appears this crossing has remained. This pipe was not part of the Feather River West Levee Improvements, Project D. Pipe is located outside the project limits. Project Improvements began at Station (Sta) 1765+00 (MA0007 about LM 1.73) to Sta 2303+50 (ST0005 about LM 1.23), refer to record drawings for the Feather River West Levee Improvement Plans Station 1765+00 to 2368+26, Project D details. (DWR UCIP - O. Magana)
5/16/2016 Feather River West Levee Improvement Project--Levee currently under construction.6/10/2015 Crossing has been modified since last inspection. 3' black plastic pipe is now running through the metal pipe and the difference was capped and welded. 12/29/2014 Same as last inspection.5/19/2014 Same as last inspection.11/6/2013 Same as last inspection.5/13/2013 SBFCA project recommends removal. Permit number and owner in detailed report book.5/7/2013 Same as last inspection. Recommend finding owner.10/30/2012 Crossing was installed about 1 foot deep--need permit authorizing work

FIELD_STRUCT_DESC: 12-inch steel irrigation pipe through the levee, 1 foot below the crown. Crossing on the landside (LS) is attached to a weir above ground. Siphon breaker located on the waterside (WS). No opening on the WS. No permit has been identified since crossing was field discovered in 2012. (Existing 12-inch steel irrigation pipe crossing remained during the Feather River West Levee Improvements, Project D). [Additional Reference(s): Sutter Butte Flood Control Agency (SBFCA) Feather River West Levee Project, Volume 4 of 6 (Project D) Feather River West Levee Improvement Plans Sta 1765+00 to 2368+26, 2016, Volume 4-SBFCA_Record_Drawings_Project D_2017.05.16.pdf, Drawing No. C-101].
FS Date: 8/9/2017

Overview of levee crown at crossing looking downstream.

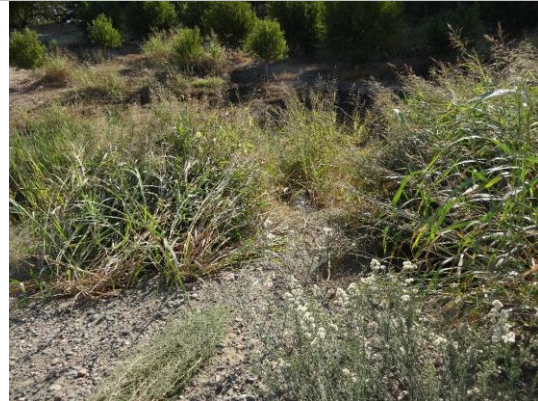
Photo 3 of 3 : UCIP_SP_2018_52386_77332.jpg

FS_ID:52386
DS_ID:20816
EP_NO: N/A
Repair Type: Non-Urgent
Crossing Status: Found
UCIP Comments: 08/09/2017 It appears that this pipe is used to water the orchard located on the WS. Dense vegetation present along the WS slope, recommend clearing vegetation to allow for proper inspection of levee slope. No permit has been identified since 2012. (DWR UCIP - O. Magana)08/02/2017 After reviewing record drawings it appears this crossing has remained. This pipe was not part of the Feather River West Levee Improvements, Project D. Pipe is located outside the project limits. Project Improvements began at Station (Sta) 1765+00 (MA0007 about LM 1.73) to Sta 2303+50 (ST0005 about LM 1.23), refer to record drawings for the Feather River West Levee Improvement Plans Station 1765+00 to 2368+26, Project D details. (DWR UCIP - O. Magana)
5/16/2016 Feather River West Levee Improvement Project--Levee currently under construction.6/10/2015 Crossing has been modified since last inspection. 3' black plastic pipe is now running through the metal pipe and the difference was capped and welded. 12/29/2014 Same as last inspection.5/19/2014 Same as last inspection.11/6/2013 Same as last inspection.5/13/2013 SBFCA project recommends removal. Permit number and owner in detailed report book.5/7/2013 Same as last inspection. Recommend finding owner.10/30/2012 Crossing was installed about 1 foot deep--need permit authorizing work

FIELD_STRUCT_DESC: 12-inch steel irrigation pipe through the levee, 1 foot below the crown. Crossing on the landside (LS) is attached to a weir above ground. Siphon breaker located on the waterside (WS). No opening on the WS. No permit has been identified since crossing was field discovered in 2012. (Existing 12-inch steel irrigation pipe crossing remained during the Feather River West Levee Improvements, Project D). [Additional Reference(s): Sutter Butte Flood Control Agency (SBFCA) Feather River West Levee Project, Volume 4 of 6 (Project D) Feather River West Levee Improvement Plans Sta 1765+00 to 2368+26, 2016, Volume 4-SBFCA_Record_Drawings_Project D_2017.05.16.pdf, Drawing No. C-101].
FS Date: 8/9/2017

WS view: dense vegetation along WS slope.

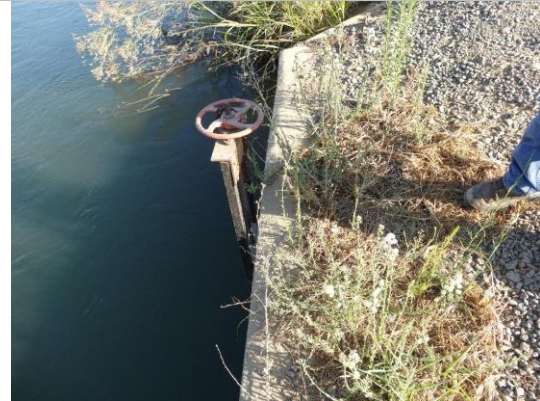
Photo 1 of 3 : UCIP_SP_2018_52387_77335.jpg

FS_ID:52387
DS_ID:16927
EP_NO: N/A
Repair Type: Non-Urgent
Crossing Status: Found
UCIP Comments: 08/09/2017 Crossing is still present, unable to confirm is crossing is still in use. Recommend contacting owner to determine status, remove dense vegetation blocking outlet, and to obtain permit authorizing crossing. (DWR UCIP - O. Magana)
08/02/2017 After reviewing record drawings it appears this crossing has remained. This pipe was not part of the Feather River West Levee Improvements, Project D. Pipe is located outside the project limits. Project Improvements began at Station (Sta) 1765+00 (MA0007 about LM 1.73) to Sta 2303+50 (ST0005 about LM 1.23), refer to record drawings for the Feather River West Levee Improvement Plans Station 1765+00 to 2368+26, Project D details. (DWR UCIP - O. Magana)
5/16/2016 Feather River West Levee Improvement Project--Levee currently under construction.6/10/2015 WS headwall is still damaged and no repairs were made to this pipe. Looks like the SBFCA project skipped over this area so pipe was not replaced as it was listed to be.12/29/2014 Same as last inspection.5/19/2014 Same as last inspection.11/6/2013 Same as last inspection.5/13/2013 SBFCA project recommends replacing with accordance to title 23.5/7/2013 Same as last inspection, however exposed rebar on WS headwall does not impede structure performance.10/31/2012 WS headwall rebar exposed. This crossing was listed in the USACE Periodic Inspections as ID# USACE_CESPK_MA07_2010_a_0051 however, no issue listed. FIELD_STRUCT_DESC: 10-inch polyvinyl chloride (PVC) pipe encased in a 12-inch corrugated metal irrigation pipe through the levee, 7 feet below the crown. Concrete U-shaped headwall at the waterside (WS) toe. Concrete headwall and slide gate on the landside (LS). Concrete weir in the canal. (Existing 10-inch PVC pipe and 12-inch corrugated metal [concrete indicated in record drawings] irrigation pipe crossing remained during the Feather River West Levee Improvements, Project D). [Additional Reference(s): DWR Levee Log, 2005. Sutter Butte Flood Control Agency (SBFCA) Feather River West Levee Project, Volume 4 of 6 (Project D) Feather River West Levee Improvement Plans Sta 1765+00 to 2368+26, 2016, Volume 4-SBFCA_Record_Drawings_Project D_2017.05.16.pdf, Drawing No. C-101].

LS view: screw gate and concrete headwall visible on LS.

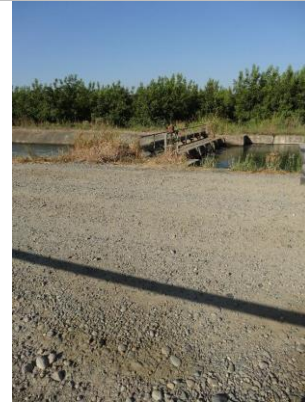
Photo 2 of 3 : UCIP_SP_2018_52387_77336.jpg

Comment Code						
Inspector Comment						
FS_ID:52387 DS_ID:16927 EP_NO: N/A Repair Type: Non-Urgent Crossing Status: Found UCIP Comments: 08/09/2017 Crossing is still present, unable to confirm is crossing is still in use. Recommend contacting owner to determine status, remove dense vegetation blocking outlet, and to obtain permit authorizing crossing. (DWR UCIP - O. Magana) 08/02/2017 After reviewing record drawings it appears this crossing has remained. This pipe was not part of the Feather River West Levee Improvements, Project D. Pipe is located outside the project limits. Project Improvements began at Station (Sta) 1765+00 (MA0007 about LM 1.73) to Sta 2303+50 (ST0005 about LM 1.23), refer to record drawings for the Feather River West Levee Improvement Plans Station 1765+00 to 2368+26, Project D details. (DWR UCIP - O. Magana) 5/16/2016 Feather River West Levee Improvement Project--Levee currently under construction.6/10/2015 WS headwall is still damaged and no repairs were made to this pipe. Looks like the SBFCA project skipped over this area so pipe was not replaced as it was listed to be.12/29/2014 Same as last inspection.5/19/2014 Same as last inspection.11/6/2013 Same as last inspection.5/13/2013 SBFCA project recommends replacing with accordance to title 23.5/7/2013 Same as last inspection, however exposed rebar on WS headwall does not impede structure performance.10/31/2012 WS headwall rebar exposed. This crossing was listed in the USACE Periodic Inspections as ID# USACE_CESPK_MA07_2010_a_0051 however, no issue listed. FIELD_STRUCT_DESC: 10-inch polyvinyl chloride (PVC) pipe encased in a 12-inch corrugated metal irrigation pipe through the levee, 7 feet below the crown. Concrete U-shaped headwall at the waterside (WS) toe. Concrete headwall and slide gate on the landside (LS). Concrete weir in the canal. (Existing 10-inch PVC pipe and 12-inch corrugated metal [concrete indicated in record drawings] irrigation pipe crossing remained during the Feather River West Levee Improvements, Project D). [Additional Reference(s): DWR Levee Log, 2005. Sutter Butte Flood Control Agency (SBFCA) Feather River West Levee Project, Volume 4 of 6 (Project D) Feather River West Levee Improvement Plans Sta 1765+00 to 2368+26, 2016, Volume 4-SBFCA_Record_Drawings_Project D_2017.05.16.pdf, Drawing No. C-101]. FS Date: 8/9/2017

Overview of levee crown at crossing.

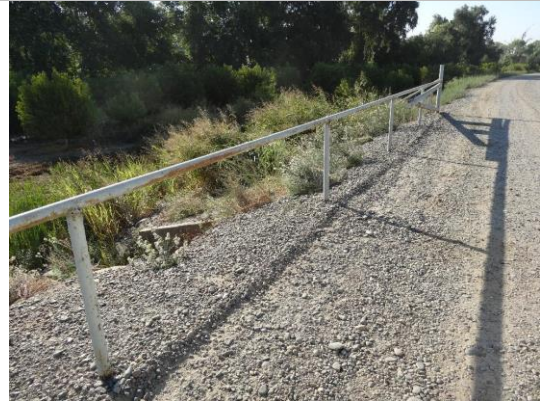
Photo 3 of 3 : UCIP_SP_2018_52387_77337.jpg

FS_ID:52387
DS_ID:16927
EP_NO: N/A
Repair Type: Non-Urgent
Crossing Status: Found
UCIP Comments: 08/09/2017 Crossing is still present, unable to confirm is crossing is still in use. Recommend contacting owner to determine status, remove dense vegetation blocking outlet, and to obtain permit authorizing crossing. (DWR UCIP - O. Magana)
08/02/2017 After reviewing record drawings it appears this crossing has remained. This pipe was not part of the Feather River West Levee Improvements, Project D. Pipe is located outside the project limits. Project Improvements began at Station (Sta) 1765+00 (MA0007 about LM 1.73) to Sta 2303+50 (ST0005 about LM 1.23), refer to record drawings for the Feather River West Levee Improvement Plans Station 1765+00 to 2368+26, Project D details. (DWR UCIP - O. Magana)
5/16/2016 Feather River West Levee Improvement Project--Levee currently under construction.6/10/2015 WS headwall is still damaged and no repairs were made to this pipe. Looks like the SBFCA project skipped over this area so pipe was not replaced as it was listed to be.12/29/2014 Same as last inspection.5/19/2014 Same as last inspection.11/6/2013 Same as last inspection.5/13/2013 SBFCA project recommends replacing with accordance to title 23.5/7/2013 Same as last inspection, however exposed rebar on WS headwall does not impede structure performance.10/31/2012 WS headwall rebar exposed. This crossing was listed in the USACE Periodic Inspections as ID# USACE_CESPK_MA07_2010_a_0051 however, no issue listed. FIELD_STRUCT_DESC: 10-inch polyvinyl chloride (PVC) pipe encased in a 12-inch corrugated metal irrigation pipe through the levee, 7 feet below the crown. Concrete U-shaped headwall at the waterside (WS) toe. Concrete headwall and slide gate on the landside (LS). Concrete weir in the canal. (Existing 10-inch PVC pipe and 12-inch corrugated metal [concrete indicated in record drawings] irrigation pipe crossing remained during the Feather River West Levee Improvements, Project D). [Additional Reference(s): DWR Levee Log, 2005. Sutter Butte Flood Control Agency (SBFCA) Feather River West Levee Project, Volume 4 of 6 (Project D) Feather River West Levee Improvement Plans Sta 1765+00 to 2368+26, 2016, Volume 4-SBFCA_Record_Drawings_Project D_2017.05.16.pdf, Drawing No. C-101].

WS view: guardrail along the WS slope and concrete headwall visible on WS.

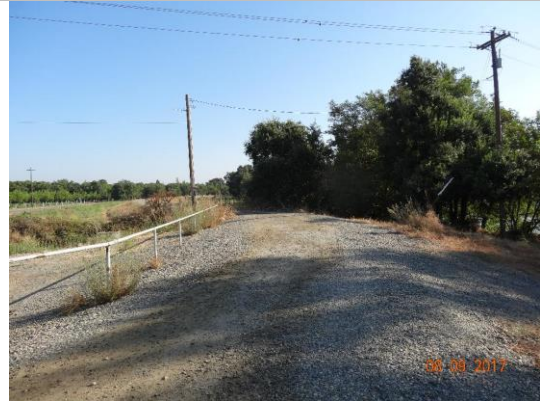
Photo 1 of 3 : UCIP_SP_2018_52390_77346.jpg

FS_ID:52390
DS_ID:16926
EP_NO: N/A
Repair Type: Non-Urgent
Crossing Status: Found
UCIP Comments: 08/09/2017 Dual 60-inch pipes are still present--no modifications appear to have been made to this structure. No permit or owner has been identified. Need to contact owner to notify of safety issue regarding the missing covers for CMP riser. (DWR UCIP - O. Magana)08/02/2017 After reviewing record drawings it appears this crossing has remained. Project Improvements begin at Station (Sta) 1765+00 (MA0007 about LM 1.73) to Sta 2303+50 (ST0005 about LM 1.23), refer to record drawings for the Feather River West Levee Improvement Plans Station 1765+00 to 2368+26, Project D details. MA0007 project details include NO CUTOFF WALL from Sta 1765+00 (MA0007 about LM 1.73) to 1815+00 (MA0007 about LM 2.64) and LEVEE DEGRADE AND RECONSTRUCTION WITH CUT OFF WALL from Sta 1817+00 (MA0007 about LM 2.69) to Sta 2289+00, Sta 2287+00 to Sta 2290+00 (MA0007 about LM 11.60). (DWR UCIP - O. Magana)

5/16/2016 Feather River West Levee Improvement Project--Levee currently under construction.6/10/2015 Debris still present in risers and pipes were not replaced with the SBFCA project.12/29/2014 Same as last inspection.5/19/2014 Same as last inspection.11/6/2013 Same as last inspection.5/13/2013 SBFCA project recommends replacing in accordance with title 23.5/7/2013 Same debris issue as last inspection. Recommend repairing top cover to prevent falls. Wheel to open gate chained and locked so could not verify gate operation.10/31/2012 Debris inside riser could prevent slide gate from closing. This crossing was listed in the USACE Periodic Inspections as ID# USACE_CESPK_MA07_2010_a_0060 however, no issues noted.
FIELD_STRUCT_DESC: 1 of 2: 60-inch corrugated metal gravity drainage pipe through the levee, 12.5 feet below the crown. Slide gate in a 78-inch corrugated metal pipe (CMP) well on the waterside (WS) slope. Concrete bulkheads on both ends. Reinforced concrete spillway on the WS end. (Existing 60-inch corrugated metal gravity drainage pipe crossing remained during the Feather River West Levee Improvements, Project D). [Additional Reference(s): DWR Levee Log, 2005. USACE Sacramento O&M Manual 152, March 1957 (Station 1+90). Sutter Butte Flood Control Agency (SBFCA) Feather River West Levee Project, Volume 4 of 6 (Project D) Feather River West Levee Improvement Plans Sta 1765+00 to 2368+26, 2016, Volume 4-SBFCA_Record_Drawings_Project D_2017.05.16.pdf, Drawing No. C-101].

Overview of levee crown looking upstream towards crossings.

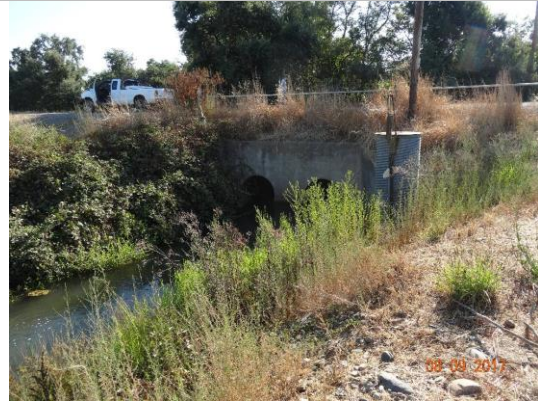
Photo 2 of 3 : UCIP_SP_2018_52390_77351.jpg

FS_ID:52390
DS_ID:16926
EP_NO: N/A
Repair Type: Non-Urgent
Crossing Status: Found
UCIP Comments: 08/09/2017 Dual 60-inch pipes are still present--no modifications appear to have been made to this structure. No permit or owner has been identified. Need to contact owner to notify of safety issue regarding the missing covers for CMP riser. (DWR UCIP - O. Magana)08/02/2017 After reviewing record drawings it appears this crossing has remained. Project Improvements begin at Station (Sta) 1765+00 (MA0007 about LM 1.73) to Sta 2303+50 (ST0005 about LM 1.23), refer to record drawings for the Feather River West Levee Improvement Plans Station 1765+00 to 2368+26, Project D details. MA0007 project details include NO CUTOFF WALL from Sta 1765+00 (MA0007 about LM 1.73) to 1815+00 (MA0007 about LM 2.64) and LEVEE DEGRADE AND RECONSTRUCTION WITH CUT OFF WALL from Sta 1817+00 (MA0007 about LM 2.69) to Sta 2289+00, Sta 2287+00 to Sta 2290+00 (MA0007 about LM 11.60). (DWR UCIP - O. Magana)

5/16/2016 Feather River West Levee Improvement Project--Levee currently under construction.6/10/2015 Debris still present in risers and pipes were not replaced with the SBFCA project.12/29/2014 Same as last inspection.5/19/2014 Same as last inspection.11/6/2013 Same as last inspection.5/13/2013 SBFCA project recommends replacing in accordance with title 23.5/7/2013 Same debris issue as last inspection. Recommend repairing top cover to prevent falls. Wheel to open gate chained and locked so could not verify gate operation.10/31/2012 Debris inside riser could prevent slide gate from closing. This crossing was listed in the USACE Periodic Inspections as ID# USACE_CESPK_MA07_2010_a_0060 however, no issues noted.
FIELD_STRUCT_DESC: 1 of 2: 60-inch corrugated metal gravity drainage pipe through the levee, 12.5 feet below the crown. Slide gate in a 78-inch corrugated metal pipe (CMP) well on the waterside (WS) slope. Concrete bulkheads on both ends. Reinforced concrete spillway on the WS end. (Existing 60-inch corrugated metal gravity drainage pipe crossing remained during the Feather River West Levee Improvements, Project D). [Additional Reference(s): DWR Levee Log, 2005. USACE Sacramento O&M Manual 152, March 1957 (Station 1+90). Sutter Butte Flood Control Agency (SBFCA) Feather River West Levee Project, Volume 4 of 6 (Project D) Feather River West Levee Improvement Plans Sta 1765+00 to 2368+26, 2016, Volume 4-SBFCA_Record_Drawings_Project D_2017.05.16.pdf, Drawing No. C-101].

LS view: concrete headwall with dual 60-inch crossings visible from LS.

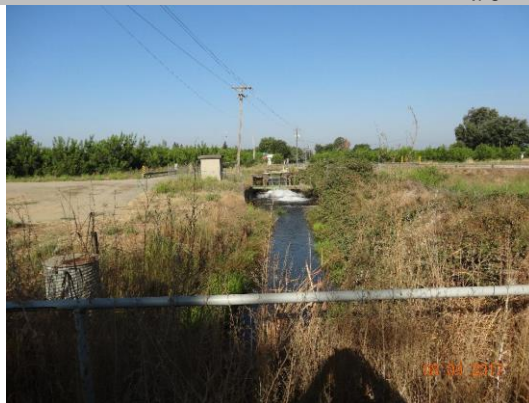
Photo 3 of 3 : UCIP_SP_2018_52390_77342.jpg

FS_ID:52390
DS_ID:16926
EP_NO: N/A
Repair Type: Non-Urgent
Crossing Status: Found
UCIP Comments: 08/09/2017 Dual 60-inch pipes are still present--no modifications appear to have been made to this structure. No permit or owner has been identified. Need to contact owner to notify of safety issue regarding the missing covers for CMP riser. (DWR UCIP - O. Magana)08/02/2017 After reviewing record drawings it appears this crossing has remained. Project Improvements begin at Station (Sta) 1765+00 (MA0007 about LM 1.73) to Sta 2303+50 (ST0005 about LM 1.23), refer to record drawings for the Feather River West Levee Improvement Plans Station 1765+00 to 2368+26, Project D details. MA0007 project details include NO CUTOFF WALL from Sta 1765+00 (MA0007 about LM 1.73) to 1815+00 (MA0007 about LM 2.64) and LEVEE DEGRADE AND RECONSTRUCTION WITH CUT OFF WALL from Sta 1817+00 (MA0007 about LM 2.69) to Sta 2289+00, Sta 2287+00 to Sta 2290+00 (MA0007 about LM 11.60). (DWR UCIP - O. Magana)

5/16/2016 Feather River West Levee Improvement Project--Levee currently under construction.6/10/2015 Debris still present in risers and pipes were not replaced with the SBFCA project.12/29/2014 Same as last inspection.5/19/2014 Same as last inspection.11/6/2013 Same as last inspection.5/13/2013 SBFCA project recommends replacing in accordance with title 23.5/7/2013 Same debris issue as last inspection. Recommend repairing top cover to prevent falls. Wheel to open gate chained and locked so could not verify gate operation.10/31/2012 Debris inside riser could prevent slide gate from closing. This crossing was listed in the USACE Periodic Inspections as ID# USACE_CESPK_MA07_2010_a_0060 however, no issues noted.
FIELD_STRUCT_DESC: 1 of 2: 60-inch corrugated metal gravity drainage pipe through the levee, 12.5 feet below the crown. Slide gate in a 78-inch corrugated metal pipe (CMP) well on the waterside (WS) slope. Concrete bulkheads on both ends. Reinforced concrete spillway on the WS end. (Existing 60-inch corrugated metal gravity drainage pipe crossing remained during the Feather River West Levee Improvements, Project D). [Additional Reference(s): DWR Levee Log, 2005. USACE Sacramento O&M Manual 152, March 1957 (Station 1+90). Sutter Butte Flood Control Agency (SBFCA) Feather River West Levee Project, Volume 4 of 6 (Project D) Feather River West Levee Improvement Plans Sta 1765+00 to 2368+26, 2016, Volume 4-SBFCA_Record_Drawings_Project D_2017.05.16.pdf, Drawing No. C-101].

LS view: view of canal looking west from crossing.

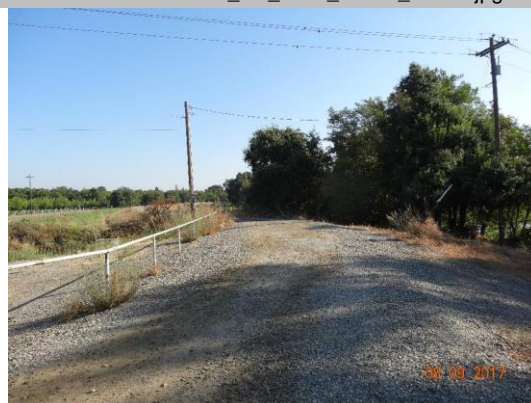
Photo 1 of 3 : UCIP_SP_2018_52389_77352.jpg

FS_ID:52389
DS_ID:17011
EP_NO: N/A
Repair Type: Non-Urgent
Crossing Status: Found
UCIP Comments: 08/09/2017 Dual 60-inch pipes are still present--no modifications appear to have been made to this structure. No permit or owner has been identified. Need to contact owner to notify of safety issue regarding the missing covers for CMP riser. (DWR UCIP - O. Magana)08/02/2017 After reviewing record drawings it appears this crossing has remained. Project Improvements begin at Station (Sta) 1765+00 (MA0007 about LM 1.73) to Sta 2303+50 (ST0005 about LM 1.23), refer to record drawings for the Feather River West Levee Improvement Plans Station 1765+00 to 2368+26, Project D details. MA0007 project details include NO CUTOFF WALL from Sta 1765+00 (MA0007 about LM 1.73) to 1815+00 (MA0007 about LM 2.64) and LEVEE DEGRADE AND RECONSTRUCTION WITH CUT OFF WALL from Sta 1817+00 (MA0007 about LM 2.69) to Sta 2289+00, Sta 2287+00 to Sta 2290+00 (MA0007 about LM 11.60). (DWR UCIP - O. Magana)

5/16/2016 Feather River West Levee Improvement Project--Levee currently under construction.6/10/2015 Debris still present inside riser and pipe was not replaced with the SBFCA project.12/29/2014 Same as last inspection.5/19/2014 Same as last inspection.11/6/2013 Same as last inspection.5/13/2013 SBFCA project recommends replacing in accordance with title 23.5/7/2013 Same as last inspection. Recommend constructing cover to prevent falls. Wheel to operate gate chained and locked so gate operation could not be verified.10/31/2012 no cover; debris inside riser could prevent slide gate from closing. This crossing was listed in the USACE Periodic Inspections as ID# USACE_CESPK_MA07_2010_a_0060 however, no issues noted.
FIELD_STRUCT_DESC: 2 of 2: 60-inch corrugated metal gravity drainage pipe through the levee, 12.5 feet below the crown. Slide gate in a 78-inch corrugated metal pipe (CMP) well on the waterside (WS) slope. Concrete bulkheads on both ends. Reinforced concrete spillway on the WS end. (Existing 60-inch corrugated metal gravity drainage pipe crossing remained during the Feather River West Levee Improvements, Project D). [Additional Reference(s): DWR Levee Log, 2005. USACE Sacramento O&M Manual 152, March 1957 (Station 1+90). Sutter Butte Flood Control Agency (SBFCA) Feather River West Levee Project, Volume 4 of 6 (Project D) Feather River West Levee Improvement Plans Sta 1765+00 to 2368+26, 2016, Volume 4-SBFCA_Record_Drawings_Project D_2017.05.16.pdf, Drawing No. C-101].

Overview of levee crown looking upstream towards crossings.

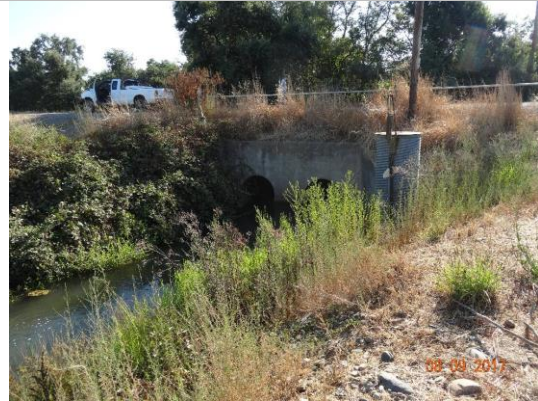
Photo 2 of 3 : UCIP_SP_2018_52389_77357.jpg

FS_ID:52389
DS_ID:17011
EP_NO: N/A
Repair Type: Non-Urgent
Crossing Status: Found
UCIP Comments: 08/09/2017 Dual 60-inch pipes are still present--no modifications appear to have been made to this structure. No permit or owner has been identified. Need to contact owner to notify of safety issue regarding the missing covers for CMP riser. (DWR UCIP - O. Magana)08/02/2017 After reviewing record drawings it appears this crossing has remained. Project Improvements begin at Station (Sta) 1765+00 (MA0007 about LM 1.73) to Sta 2303+50 (ST0005 about LM 1.23), refer to record drawings for the Feather River West Levee Improvement Plans Station 1765+00 to 2368+26, Project D details. MA0007 project details include NO CUTOFF WALL from Sta 1765+00 (MA0007 about LM 1.73) to 1815+00 (MA0007 about LM 2.64) and LEVEE DEGRADE AND RECONSTRUCTION WITH CUT OFF WALL from Sta 1817+00 (MA0007 about LM 2.69) to Sta 2289+00, Sta 2287+00 to Sta 2290+00 (MA0007 about LM 11.60). (DWR UCIP - O. Magana)

5/16/2016 Feather River West Levee Improvement Project--Levee currently under construction.6/10/2015 Debris still present inside riser and pipe was not replaced with the SBFCA project.12/29/2014 Same as last inspection.5/19/2014 Same as last inspection.11/6/2013 Same as last inspection.5/13/2013 SBFCA project recommends replacing in accordance with title 23.5/7/2013 Same as last inspection. Recommend constructing cover to prevent falls. Wheel to operate gate chained and locked so gate operation could not be verified.10/31/2012 no cover; debris inside riser could prevent slide gate from closing. This crossing was listed in the USACE Periodic Inspections as ID# USACE_CESPK_MA07_2010_a_0060 however, no issues noted.
FIELD_STRUCT_DESC: 2 of 2: 60-inch corrugated metal gravity drainage pipe through the levee, 12.5 feet below the crown. Slide gate in a 78-inch corrugated metal pipe (CMP) well on the waterside (WS) slope. Concrete bulkheads on both ends. Reinforced concrete spillway on the WS end. (Existing 60-inch corrugated metal gravity drainage pipe crossing remained during the Feather River West Levee Improvements, Project D). [Additional Reference(s): DWR Levee Log, 2005. USACE Sacramento O&M Manual 152, March 1957 (Station 1+90). Sutter Butte Flood Control Agency (SBFCA) Feather River West Levee Project, Volume 4 of 6 (Project D) Feather River West Levee Improvement Plans Sta 1765+00 to 2368+26, 2016, Volume 4-SBFCA_Record_Drawings_Project D_2017.05.16.pdf, Drawing No. C-101].

LS view: concrete headwall with dual 60-inch crossings.

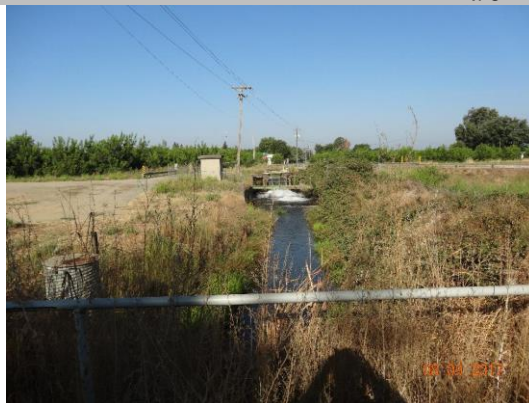
Photo 3 of 3 : UCIP_SP_2018_52389_77358.jpg

FS_ID:52389
DS_ID:17011
EP_NO: N/A
Repair Type: Non-Urgent
Crossing Status: Found
UCIP Comments: 08/09/2017 Dual 60-inch pipes are still present--no modifications appear to have been made to this structure. No permit or owner has been identified. Need to contact owner to notify of safety issue regarding the missing covers for CMP riser. (DWR UCIP - O. Magana)08/02/2017 After reviewing record drawings it appears this crossing has remained. Project Improvements begin at Station (Sta) 1765+00 (MA0007 about LM 1.73) to Sta 2303+50 (ST0005 about LM 1.23), refer to record drawings for the Feather River West Levee Improvement Plans Station 1765+00 to 2368+26, Project D details. MA0007 project details include NO CUTOFF WALL from Sta 1765+00 (MA0007 about LM 1.73) to 1815+00 (MA0007 about LM 2.64) and LEVEE DEGRADE AND RECONSTRUCTION WITH CUT OFF WALL from Sta 1817+00 (MA0007 about LM 2.69) to Sta 2289+00, Sta 2287+00 to Sta 2290+00 (MA0007 about LM 11.60). (DWR UCIP - O. Magana)

5/16/2016 Feather River West Levee Improvement Project--Levee currently under construction.6/10/2015 Debris still present inside riser and pipe was not replaced with the SBFCA project.12/29/2014 Same as last inspection.5/19/2014 Same as last inspection.11/6/2013 Same as last inspection.5/13/2013 SBFCA project recommends replacing in accordance with title 23.5/7/2013 Same as last inspection. Recommend constructing cover to prevent falls. Wheel to operate gate chained and locked so gate operation could not be verified.10/31/2012 no cover; debris inside riser could prevent slide gate from closing. This crossing was listed in the USACE Periodic Inspections as ID# USACE_CESPK_MA07_2010_a_0060 however, no issues noted.
FIELD_STRUCT_DESC: 2 of 2: 60-inch corrugated metal gravity drainage pipe through the levee, 12.5 feet below the crown. Slide gate in a 78-inch corrugated metal pipe (CMP) well on the waterside (WS) slope. Concrete bulkheads on both ends. Reinforced concrete spillway on the WS end. (Existing 60-inch corrugated metal gravity drainage pipe crossing remained during the Feather River West Levee Improvements, Project D). [Additional Reference(s): DWR Levee Log, 2005. USACE Sacramento O&M Manual 152, March 1957 (Station 1+90). Sutter Butte Flood Control Agency (SBFCA) Feather River West Levee Project, Volume 4 of 6 (Project D) Feather River West Levee Improvement Plans Sta 1765+00 to 2368+26, 2016, Volume 4-SBFCA_Record_Drawings_Project D_2017.05.16.pdf, Drawing No. C-101].

LS view: canal located on LS, photo taken from levee crown looking west.

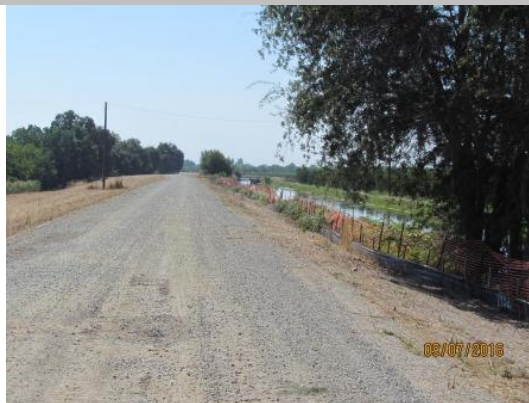
Photo 1 of 1 : SP_2018_MA0007_200_39_20180302_00004.jpg

View of Landside ditch looking downstream.

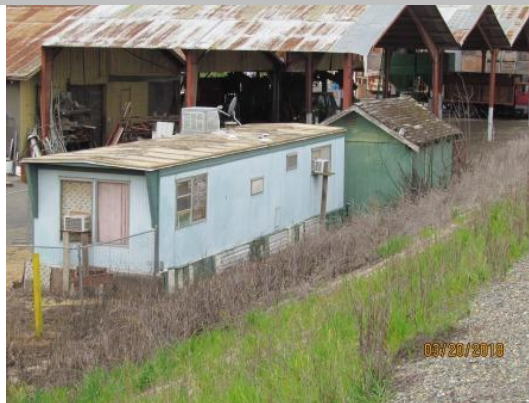
Photo 1 of 1 : SP_2018_MA0007_200_45_20180402_00039.jpg

LM Start	9.65	Rating **	U	Issue No.	45
LM End	9.65	Issue Type +	En	Location *	LS
Category	Earthen Levee			GPS Latitude/Longitude	
				Start	End
Item	Encroachments			39.416384 °	39.416384 °
				-121.634503 °	-121.634503 °
DWR ID	DWR_MA0007_01_s_2012_45				
Comment Code					
BU : Building					
Inspector Comment					
Trailer is still at landside levee toe, no permit found, Spring 2018.

This photo shows a building at the landside toe, no permit found, Spring 2018.

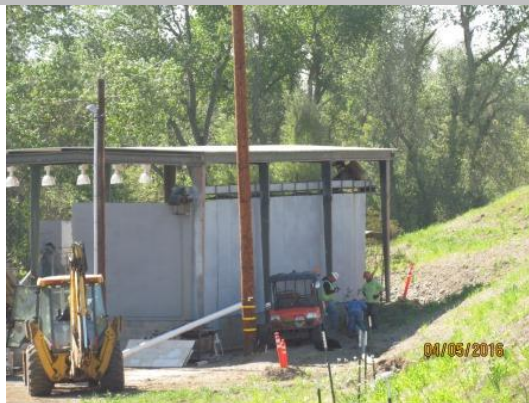
Photo 1 of 1 : SP_2018_MA0007_200_40_20180302_00005.jpg

LM Start	11.49	Rating **	M	Issue No.	40
LM End	11.49	Issue Type +	En	Location *	WS
Category	Earthen Levee			GPS Latitude/Longitude	
				Start	End
Item	Encroachments			39.437454 °	39.437454 °
				-121.646024 °	-121.646024 °
DWR ID	DWR_MA0007_01_s_2016_40				
Comment Code					
BU : Building					
Inspector Comment					
No permit found, Fall 2017.

View showing structure, waterside, looking downstream.
